Linnwood to Riverside Water Conveyance Tunnel Milwaukee, WI

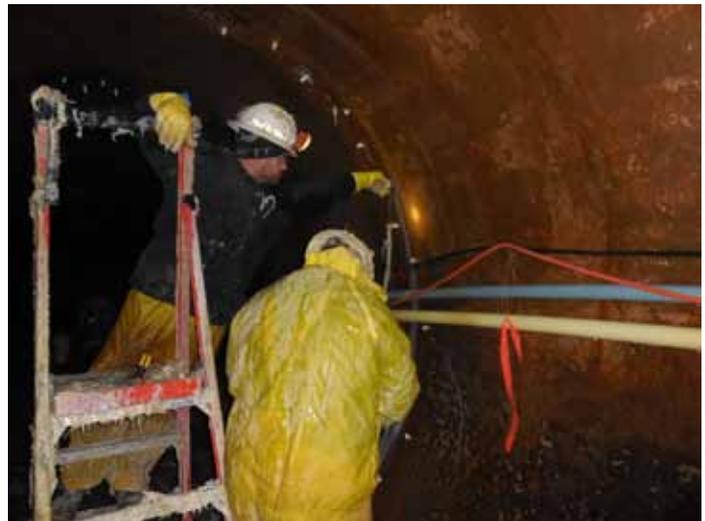
Injection grouting crew
