Complex Retention System for Texas Capitol

Charles A. Luxford, P.E., S.E., and Eric S. Lindquist, Ph.D., P.E., Brierley Associates

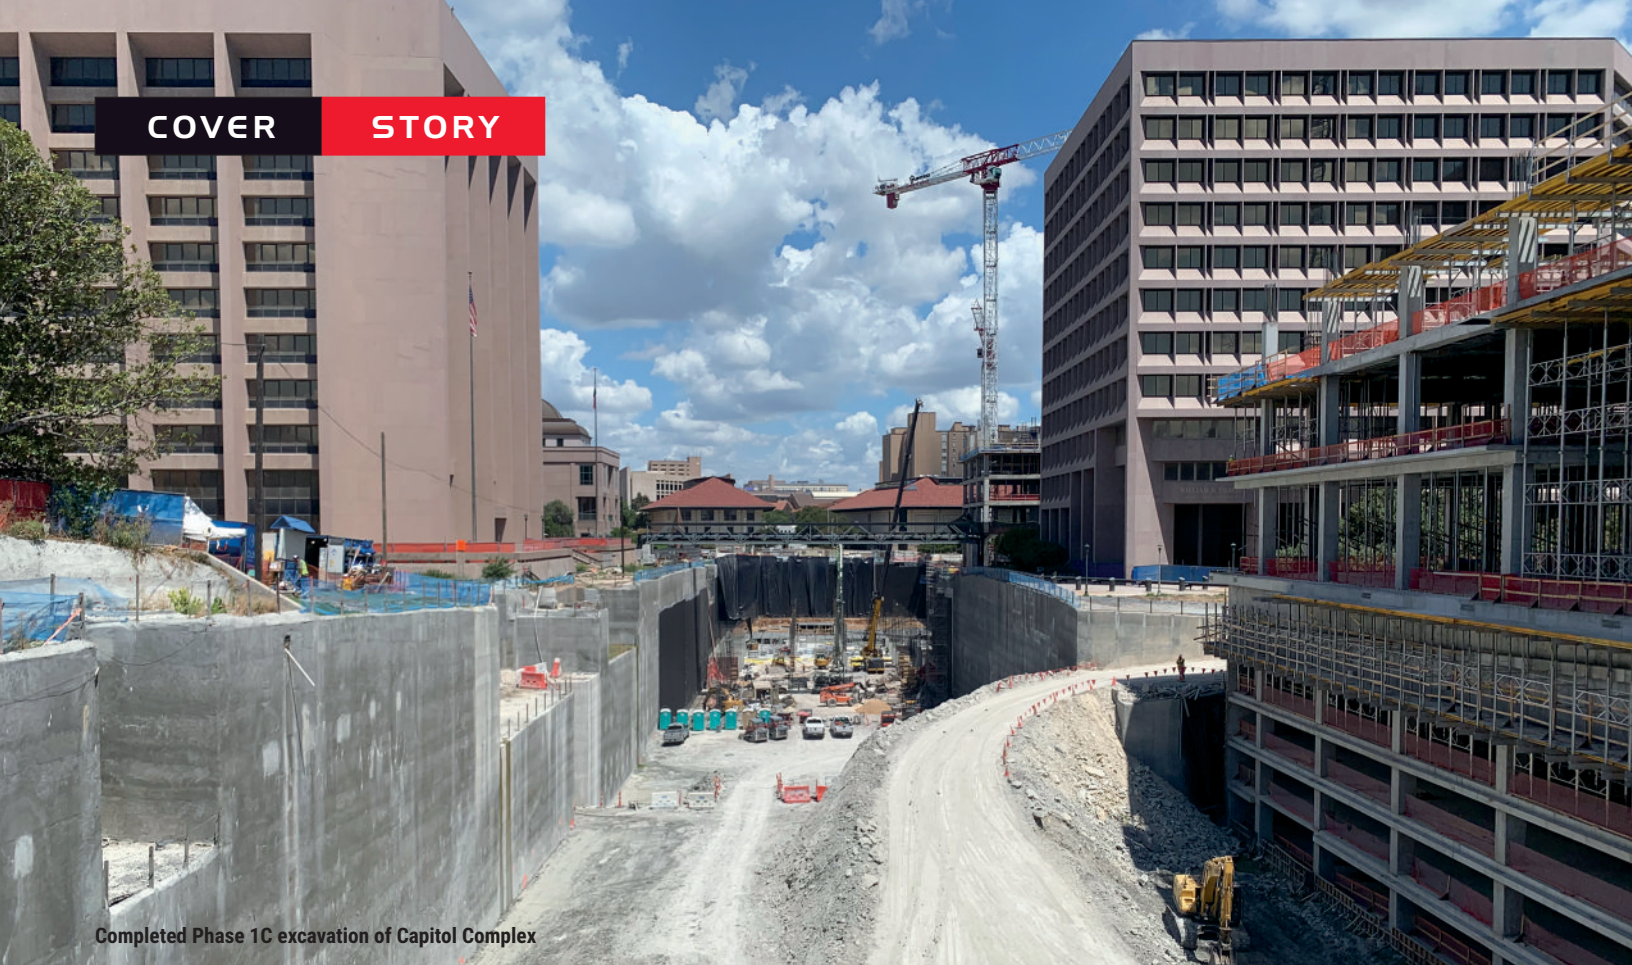
Completed Phase 1C excavation of Capitol Complex

Phase 1 of the Capitol Complex Expansion excavated three blocks of the Congress Avenue right-of-way, from MLK Jr. Blvd. (19th Street) to 16th Street and two adjoining surface parking lots. The site was excavated to an average depth of 60 ft (18 m) over a footprint exceeding 10 acres (4 ha), with a total excavated volume in excess of 500,000 yd³ (380,000 m³). The Phase 1 plan involved six construction packages, with the excavation package subdivided into three subphases that were developed in staggered intervals (1A: 1801 Congress building; 1B: 1601 Congress building; and 1C: Congress Avenue garage). As each permanent structure package has separate design and construction teams, the state procured a design-bid-build contract for the entire Phase 1 excavation for coordination purposes. BIM (building information management) modeling was utilized for the design to resolve preconstruction conflicts; however, field geotechnical observations during construction proved vital to managing and mitigating project risk.
