Design Build Landslide Remediation, Crookston, MN

Phillip Burgmeier, PE and Kris Burnham

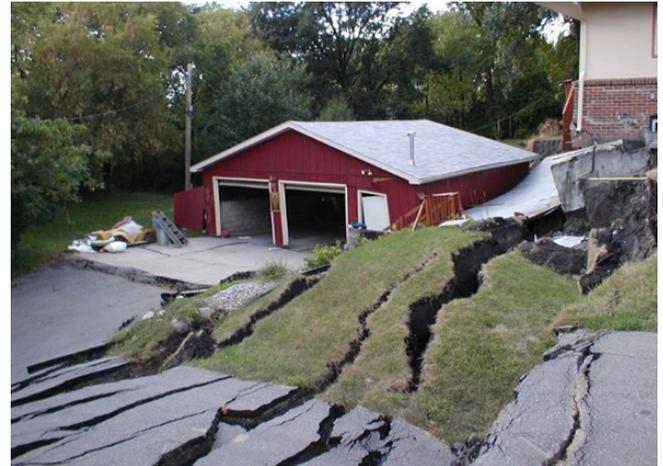
The 2003 landslide scarp was approximately 20-ft high and adjacent to the south side of TH 2. Given the location of the scarp, the busy corridor and adjoining homes were threatened. In response to the slide, Minnesota Department of Transportation (MnDOT) undertook a monitoring program with the objective of developing a conceptual site model relative to slide mechanisms.

2003 Photo of Damage, Courtesy of MnDOT

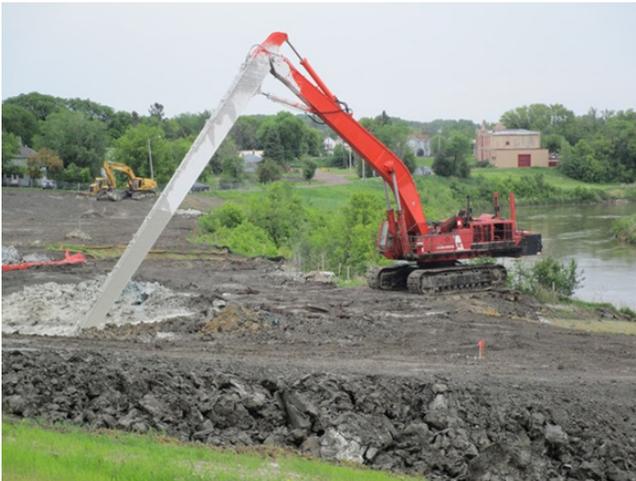
“Long Stick” excavator used to construct the CB shear walls.

The shear walls were constructed using cement bentonite (CB) slurry, designed to reach an ultimate compressive strength of 250 psi. CB wall installation was by Inquip Associates, Inc. using one of the world’s largest long-reach excavators. The shear walls were excavated to a width of 3-ft and a depth of 75-ft to extend about 10-ft into the underlying ground moraine. Typical wall lengths were 100-ft and were broken into two 50-ft sections. Shorter walls at 50-ft lengths were used to accommodate the geometric constraints of the existing surface drains.
