EBMUD CARISBROOK RESERVOIR ROOF DEMOLITION

David Berti, PE, SE, Senior Consultant: Brierley Associates, Moraga CA

Greg Overhage, Project Manager: Sierra Mountain Construction, Sonora, CA

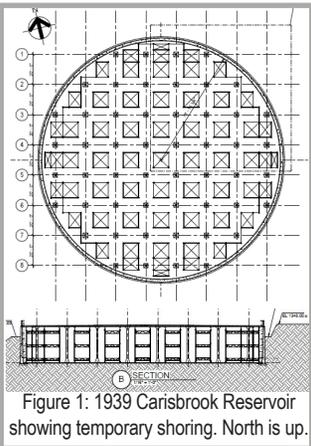
Figure 1: 1939 Carisbrook Reservoir showing temporary shoring. North is up.

Walls of the 25± ft deep tank had been post-tensioned with high-strength rods and then covered with shotcrete. The roof slab was a two-way slab (no beams) with supporting columns at 20-ft centers each way with top and bottom capitals. See Figure 1. The slab was reinforced with #4 rebars top and bottom at 4-inch to 10-inch spacing. Drawings indicate a 100-psf design live load and 88-psf dead load for the 6.75-inch thick slab. The two-way slab was divided into continuous column strips and middle strips each way, in 10-ft widths. Most of the rebar was in the column strips.

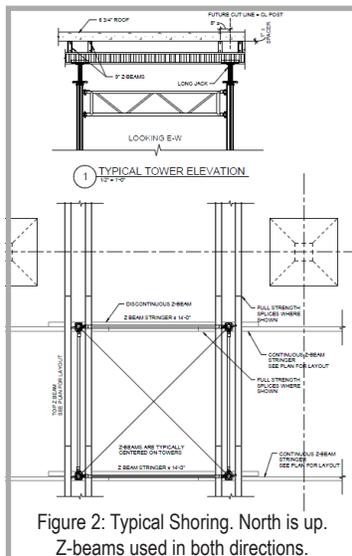
Figure 2: Typical Shoring. North is up. Z-beams used in both directions.

In order to remove the roof from east to west as needed, it was necessary to install temporary shoring. Sierra retained Brierley Associates to design the shoring and the group chose EFCO E-Z Deck Shoring towers for deck support. The modular system was relatively easy to install. Basic towers were 10-ft square in plan and used Z-beams in both directions. Our Kanab, Utah office prepared CAD drawings, thereby simplifying the detailing process so that the shoring could be installed in its correct location without any hitches. Most of the Z-beams were made continuous by end bolting.

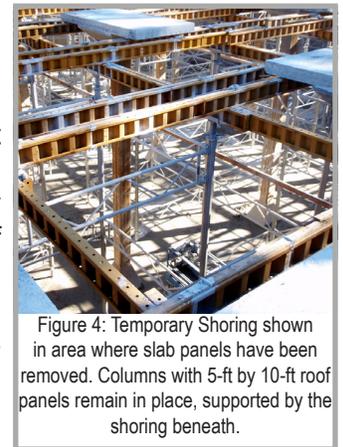
Figure 4: Temporary Shoring shown in area where slab panels have been removed. Columns with 5-ft by 10-ft roof panels remain in place, supported by the shoring beneath.

First, an access hole was cut in the slab and the shoring was installed. Then concrete saws were used to cut the roof panels into 5-ft by 10-ft maximum rectangular panels. Once cut, the panels were then picked by a 28±-kip Broderson IC-200 roof crane, moved on the roof with forklifts, and loaded onto trucks with a large exterior crane. Except for those panels attached to the columns, the concrete roof panels were completely removed from east to west as planned, leaving the 52 columns and the supporting shoring below. See Figure 4.

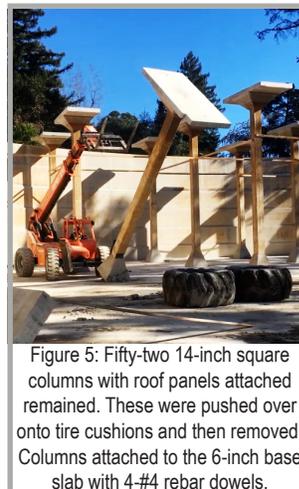
Figure 5: Fifty-two 14-inch square columns with roof panels attached remained. These were pushed over onto tire cushions and then removed. Columns attached to the 6-inch base slab with 4-#4 rebar dowels.

After the shoring was completely removed, the large exterior crane lowered a forklift onto the base slab. The forklift pushed over the columns as shown on Figure 5. Demolition work was completed with no major problems or difficulties.
