Landslide – Trinidad, Colorado

Bill Zietlow, PE

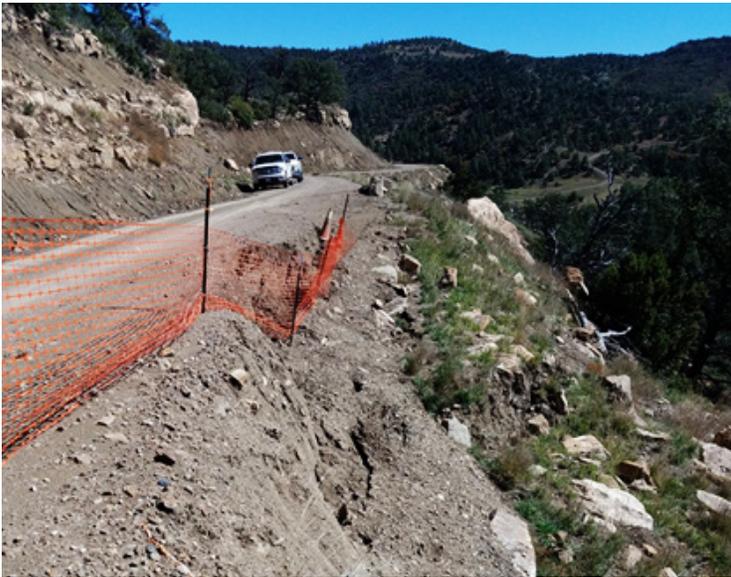
Regionally, during the first six months of 2017, total precipitation was about 50% more than average. Then, in August 2017 a sudden ground movement occurred which disrupted the use of an unpaved access road that hugs the side of a canyon. The landslide was approximately 200-ft long and somewhat parallel to the roadway, with a more active center portion about 100- to 150-ft wide.

By October 2017, the main scarp below the roadway surface had advanced several feet towards the road thus reducing the overall width. Formation of a secondary scarp further undercut the road resulting in a single travel lane. By December 2017, the top of the slide had advanced further toward the road and the secondary scarp had expanded horizontally several feet effectively closing the road.

Although tiebacks are the traditional landslide stabilization technique, Brierley believed that a soil nail wall embedded in shale bedrock, below the slide surface would be feasible. For this remedy to work, it was critical to determine the slide plane depth and geometry. Typically, landslide geometry is determined by monitoring deformation over time with inclinometers. However, due to the need to reopen the road quickly, Brierley implemented the observational method to develop our design rather than extending the project timeframe by several months, which would have been needed if geotechnical instrumentation was installed and monitored. During soil nail wall construction, Brierley mapped the excavation. This information allowed us to adjust the soil nail wall bottom so it extended below the slide plane. Upon installation of the soil nail wall, the deepened portion was backfilled to protect the base of the stabilized ground mass from future erosion.

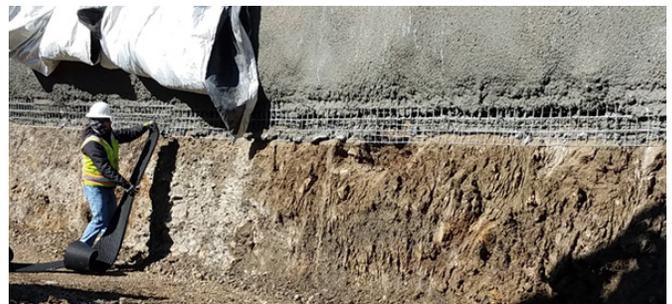
Although the landslide turned out to be significantly deeper than initially assessed, Brierley's observational approach led to a flexible design that allowed for modifications as conditions became apparent, which ultimately avoided construction delays. The final wall geometry ended up about 30-ft deep near the center of the landslide and was terminated within the underlying bedrock. The project required five weeks to construct, followed by final road grading and drainage work and was completed prior to the start of the 2018 snow/rain season.
