# Tunneling success at Denver's Platte to Park Hill project is a team effort

The largest and most complex phase of the project is the Globeville landing outfall — a \$70-million box culvert project that includes a pair of 157-m (515-ft) long, 243-cm (96-in.) diameter storm water tunnels that pass beneath a busy rail yard with 17 tracks for the Union Pacific Railroad (UPRR) and two Regional Transportation District (RTD) commuter rail tracks. The tunnels, which were installed parallel to a pair of existing 243-cm (96-in.) tunnels, were designed by Brierley Associates as a client of Merrick & Company for the City & County of Denver, and Bradshaw Construction constructed the one-pass tunnels.

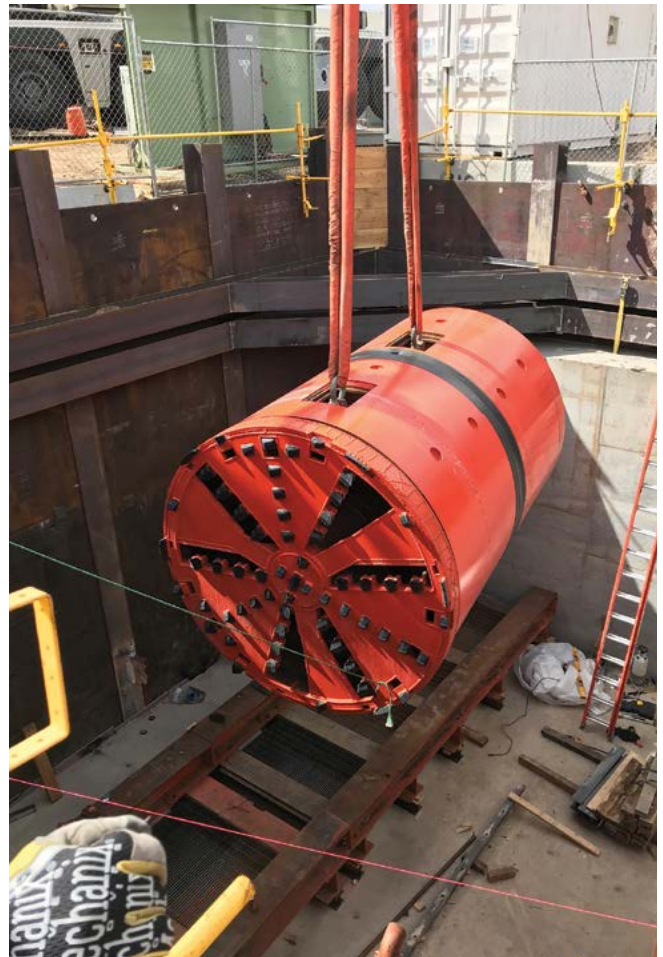
**The microtunneling boring machine is lowered to begin boring the first of two storm water tunnels in Denver, CO. Photos courtesy of Kyle Friedman, Brierley Associates.**

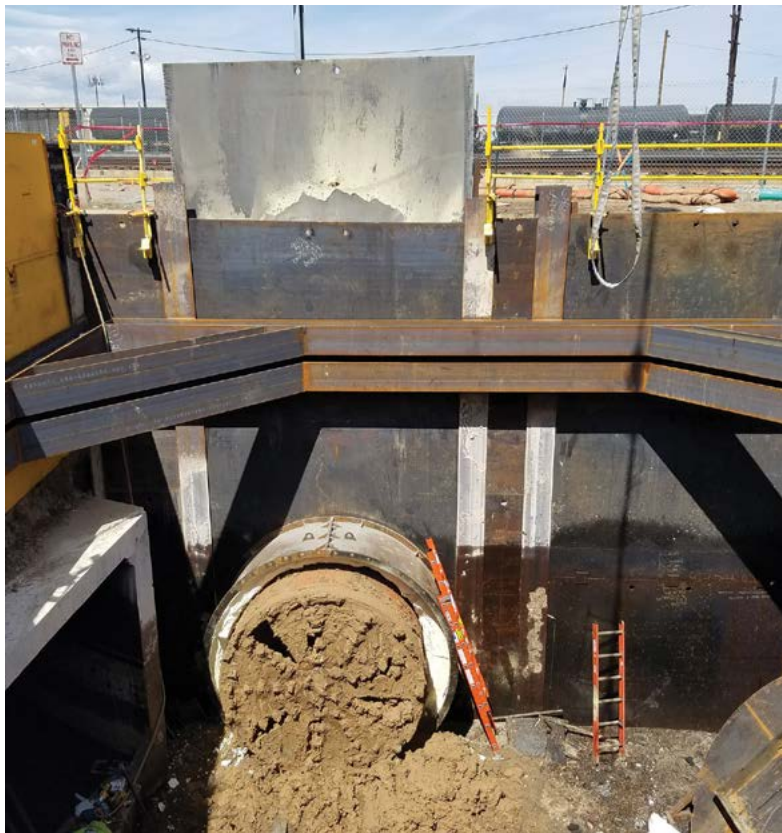
**A microtunnel boring machine breaks through as part of Denver’s Platte to Park Hill Project. The 157-m (515-ft) storm water tunnel passed beneath 17 Union Pacific and two commuter rail lines.**
